UNIVERSITY OF KENTUCKY  
OCCUPATIONAL HEALTH & SAFETY

**INDUSTRIAL HYGIENE REPORT:  
Urethane Deck Coating Exposures  
ASTeCC Building**

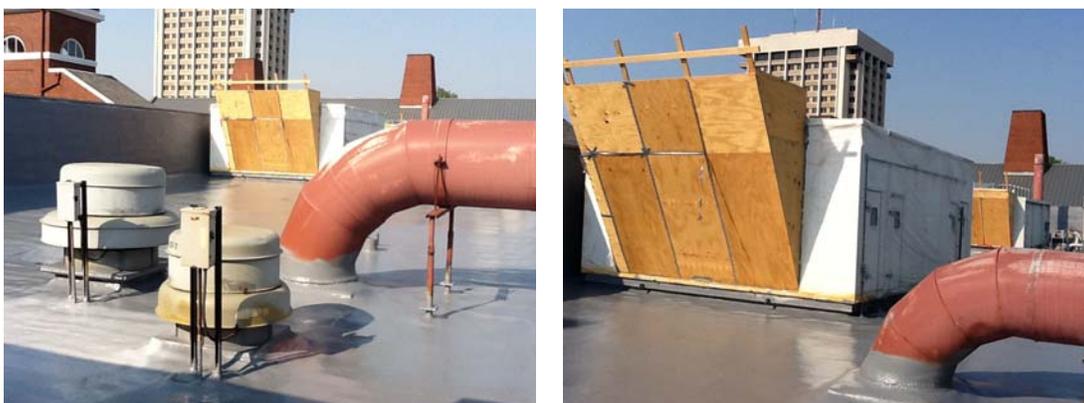
*Photos above show rooftop following application of Basecoat. Modifications to air intake (wooden deflector, doors sealed with plastic sheeting) are visible.*

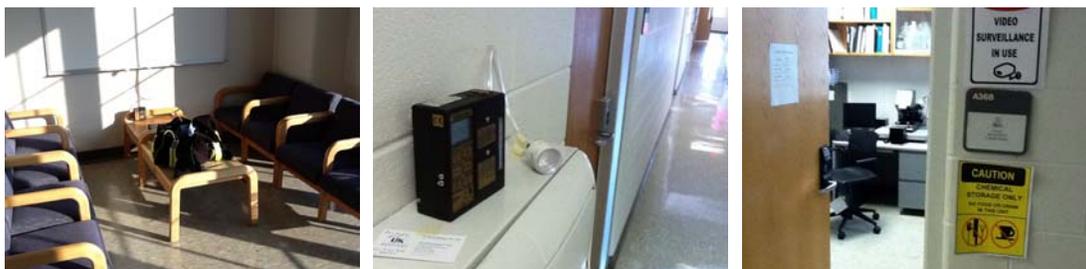
For post-Basecoat sampling on 8/31/11, a total of three sampling pumps were deployed. Based on the area of the roof where the Basecoat had been most recently applied relative to the roof-mounted building HVAC systems, it was determined that the third floor should be the focus of sampling. Pumps were placed in the atrium between ASTeCC and McVey near the elevators, in the hallway outside A-358 (office of TrackFive Diagnostics LLC), and inside A-368 (CeNSE Measuring Laboratory of Drs. Vijay Singh and Chuck May). See photos below.

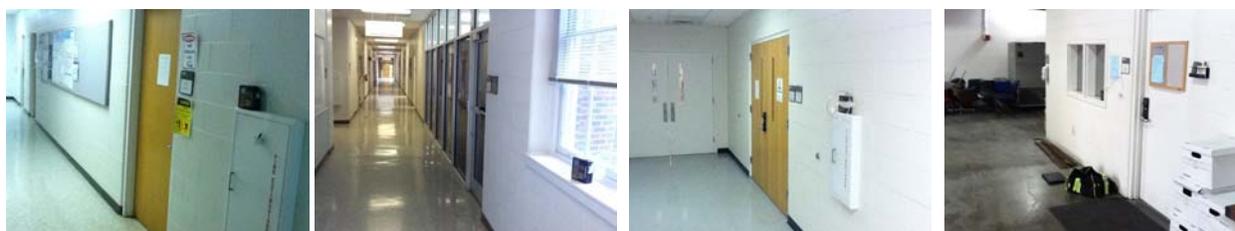
For the Topcoat sampling on 9/1/11, multiple floors were sampled because the rooftop work was going to be more widespread. Pumps were deployed on the windowsill near A-368 (CeNSE Lab), 2<sup>nd</sup> floor hallway next to A-256 (L. Heller office), hallway next to A-057 (YT Cheng Lab), and in the receiving area outside A-033C (L. Farmer office). See photos below.
