UNIVERSITY OF KENTUCKY  
OCCUPATIONAL HEALTH & SAFETY

**INDUSTRIAL HYGIENE REPORT:  
Urethane Deck Coating Exposures  
Taylor Education Building**

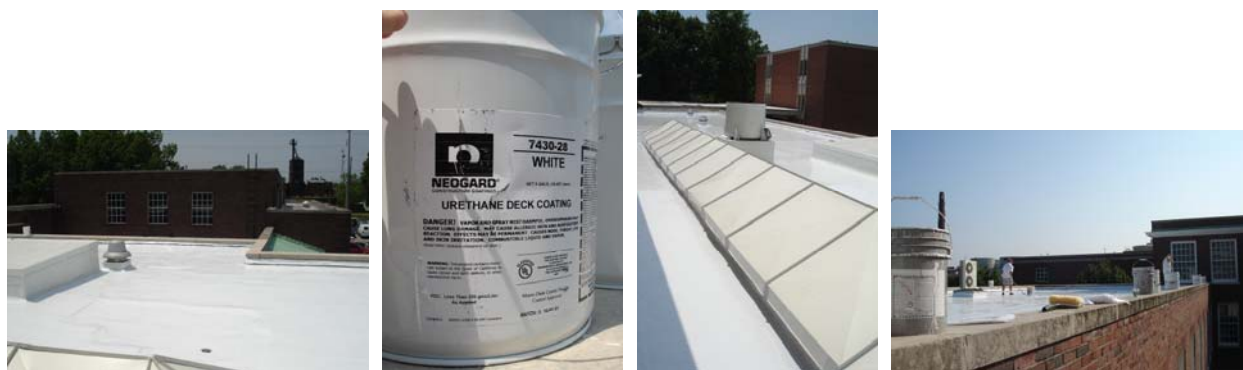
The crew applied the coating using paint rollers with extension poles. Because vapors from this coating are heavier than air, they tend to sink below the roof level and were thus detectable within certain areas of Taylor with a portable photo ionization detector (PID). Two coats were applied to all flat sections, with the second coat not applied until the roof was completely dry from the first coat as well as subsequent dew/condensation.

*Photos of various segments of the Taylor Education Building roof receiving a urethane deck coating*

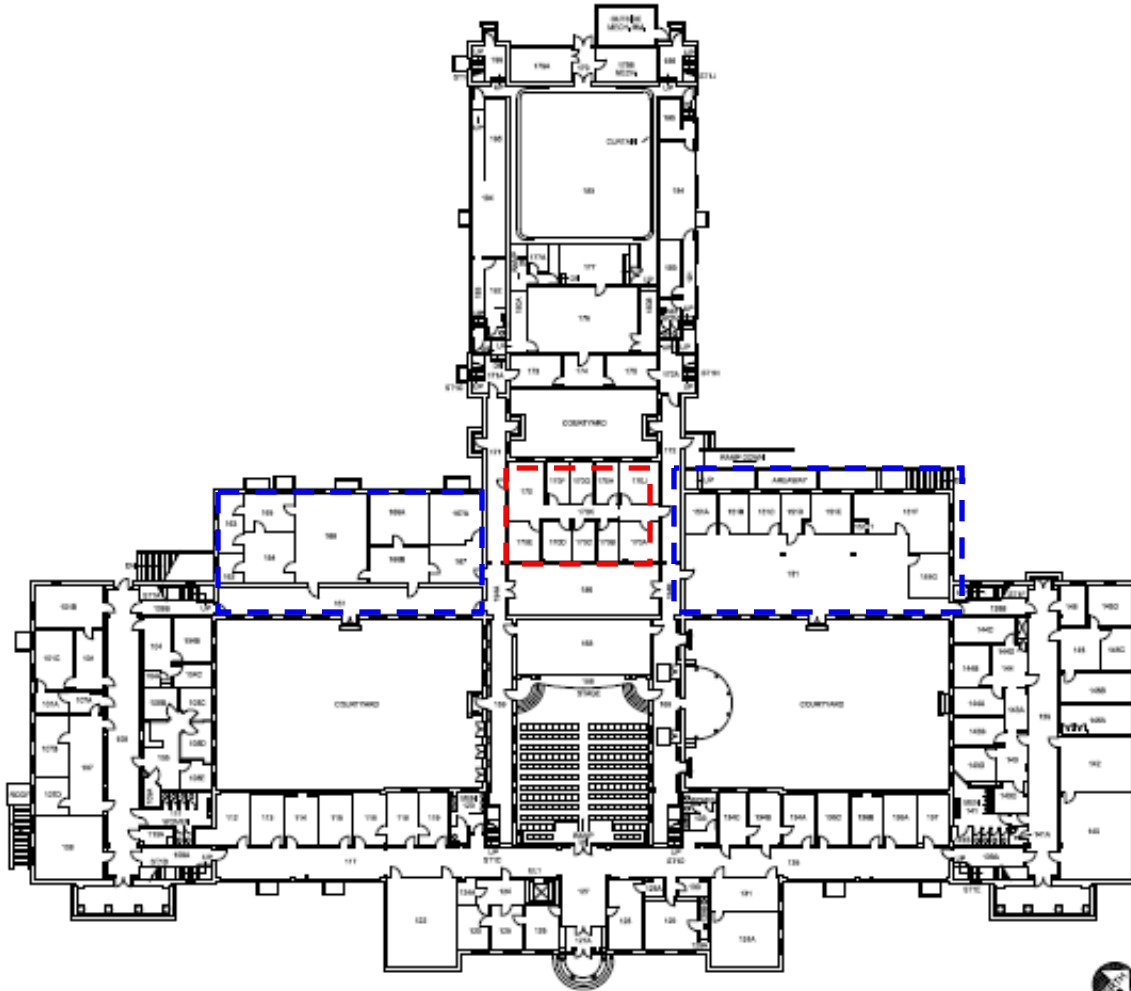
The EDP personnel in the 170 suite became aware of the project on Thursday, June 2, 2011, due to the presence of previously unknown odors within their suite. They did not call OHS until June 6, after the odors returned following a weekend away and became strong enough to disrupt regular work activities. OHS arrived on-site later that day to begin the assessment.

*First-floor plan, Taylor Education Building. The 170 suite is located within the red-dashed box. The blue-dashed boxes indicate areas where deck compound was being applied to flat-roof surfaces on 6/7/11.*

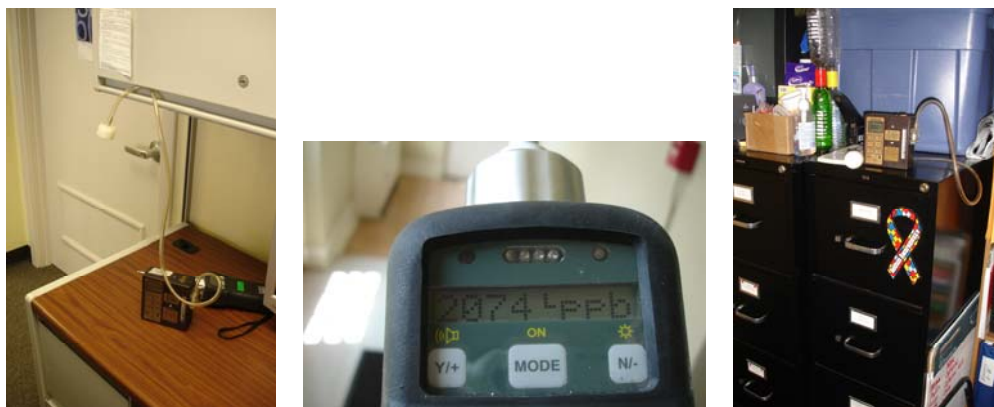
*Sampling pumps with treated glass-fiber filters (left, right) and a photo-ionization detector (center) were used to measure exposures in the 170 suite.*

On all samples collected, neither isomer of TDI could be detected. The OSHA-42 method is sensitive, and has a lower detection limit of 0.1 micrograms per sample. Based on these results, OHS concludes that **on the day of sampling (6/7/11), no detectable exposures to TDI occurred within the 170 suite.**

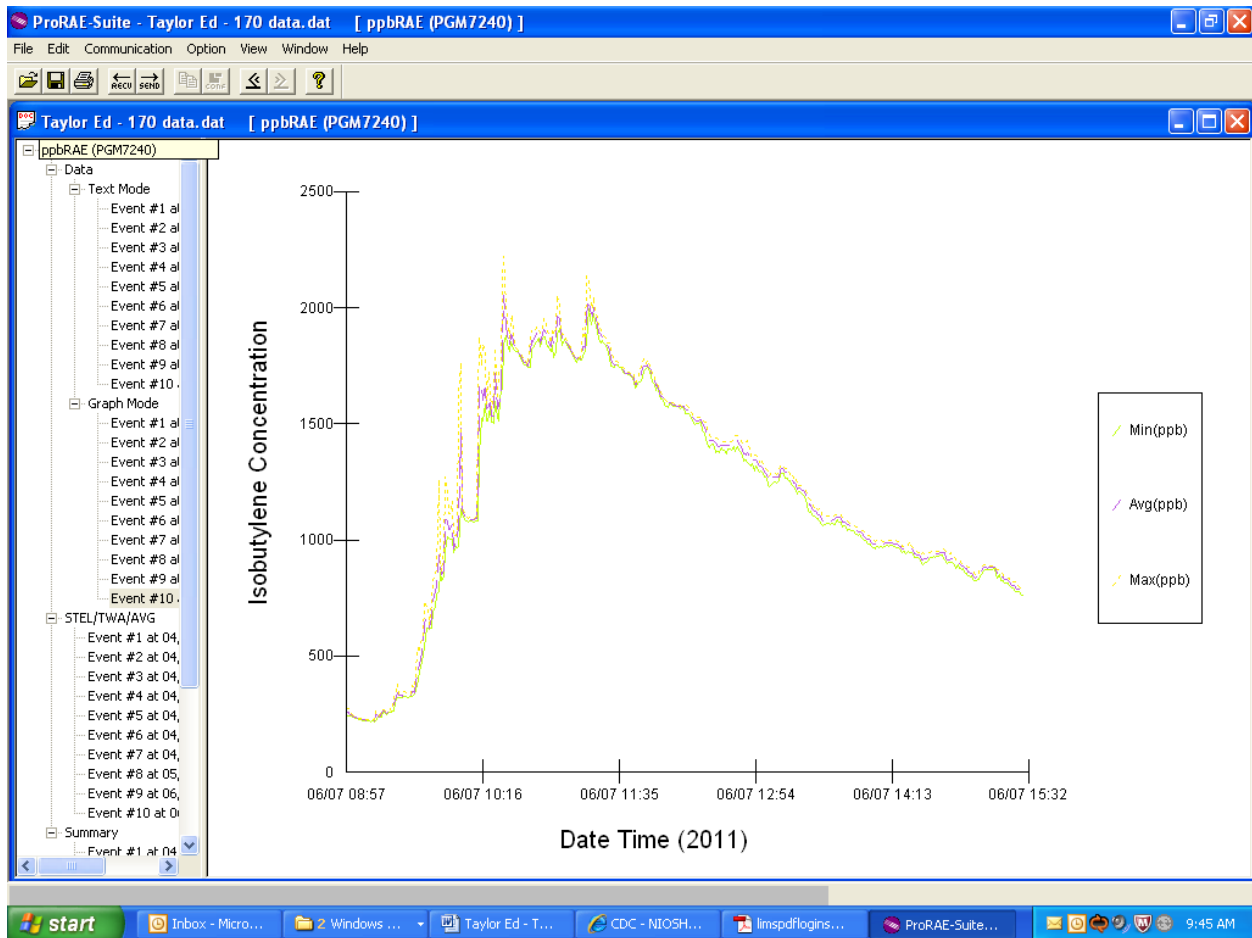
The PID readings are shown below. Between approximately 10am and 11:30am, peak VOC levels between 2000 and 2200 parts per billion were detected, but throughout the day there were levels detectable with both the PID and through the occupants' sense of smell.

Assuming that these results are solely due to petroleum distillates and not limonene/menthadiene, the exposure levels were still well below the current OSHA PEL for petroleum distillates (500 parts per million). However, they were present at levels far above the odor threshold, and some employees reported symptoms such as eye and respiratory irritation and mild nausea due to the vapors.

- Consult with the Building Operator about whether it might be feasible to temporarily modify (or even shut down) building HVAC systems in order to reduce the potential re-entrainment of vapors during future projects.
