UNIVERSITY OF KENTUCKY  
OCCUPATIONAL HEALTH & SAFETY

**INDUSTRIAL HYGIENE REPORT:  
Urethane Deck Coating Exposures  
Taylor Education Building**

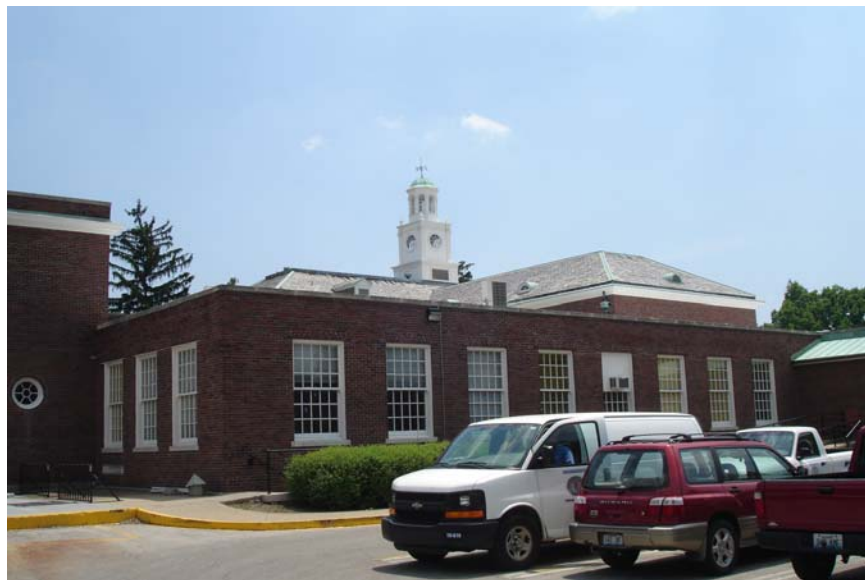
The crew applied the coating using paint rollers with extension poles. Because vapors from this coating are heavier than air, they tend to sink below the roof level and were thus detectable within certain areas of Taylor with a portable photo ionization detector (PID). Two coats were applied to all flat sections, with the second coat not applied until the roof was completely dry from the first coat as well as subsequent dew/condensation.

*Photos of various segments of the Taylor Education Building roof receiving a urethane deck coating*
